# Working together

## Defective warning horns in snowy weather

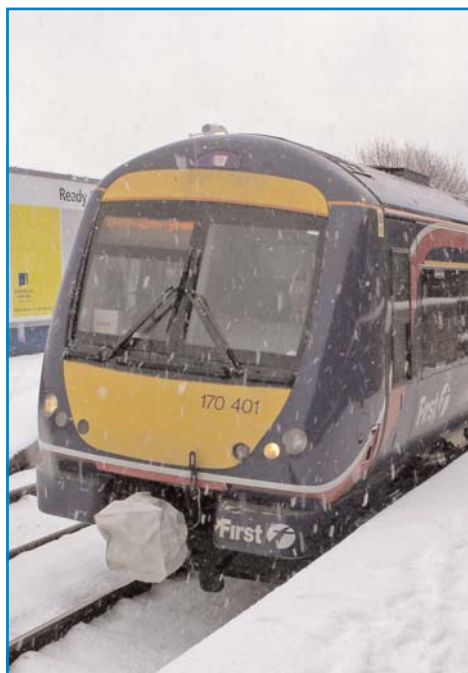
Following a report that was previously made to CIRAS, an additional concern has been raised regarding warning horns on class 158 and 170 trains in Scotland. The concern relates to the horns becoming defective during

Could the warning horn be repositioned?

snowy conditions. The reporter has highlighted that these horns become congested with snow during flurries, preventing staff from sounding them when needed. This is believed to be as a result of the sleeve used to cover the horns becoming ineffective when trains drive into flurries and also, possibly, because of their poor positioning. The concern is that it only takes a small amount of snow to make the warning horn defective.

Initially, First ScotRail investigated this particular problem which was mitigated by fitting a sleeve over the horn to prevent snow ingress. Engineers reviewed options considering whether the horn could be re-located but this would involve intrusive modifications. The option favoured was to fit trace heating, which involves a low voltage supply to the horn box, which could be retrofitted to existing train horns. Subsequently they have undertaken a review of horn failures due to freezing weather.

The existing sock arrangement is considered adequate as it does provide protection from the elements and driving snow while not diminishing the sound level of the horns. Based on the cost benefits analysis and the safety mitigation that is in place as per the *Rule Book* and SOM303 it has been recommended that a fleet campaign change is not undertaken at this time.

Instead, this modification should be applied during the future overhaul of the horns undertaken at C6.

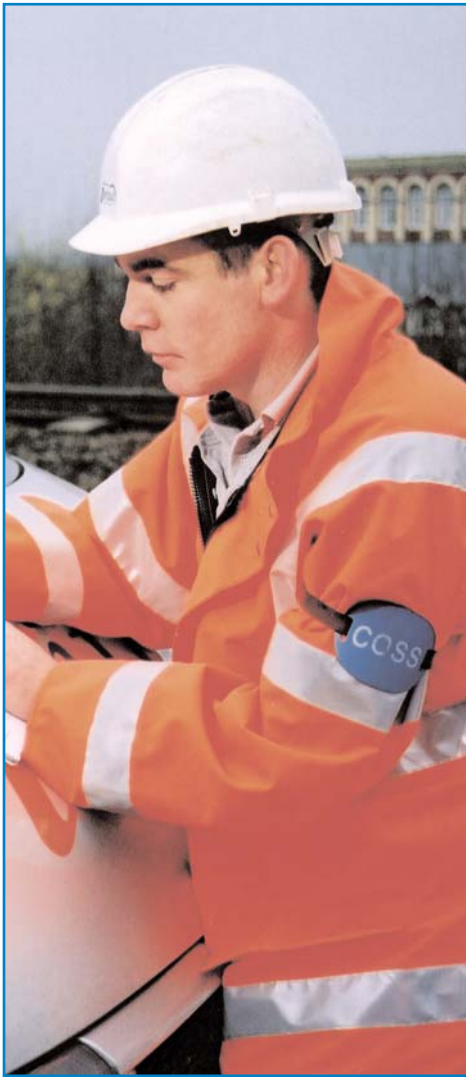
One COSS has been supervising two platforms

The primary concern is that one COSS has been appointed to supervise work sites on two separately located platforms. The reporter goes on to list other examples of unsafe working practices being carried out:

- Workers taking scaffolding down from under a footbridge with no protection. Should a T3 have been taken here?
- A method statement affirming that the COSS should keep everybody on the inner side of the yellow line, away from the platform edge - however scaffolding towers are being put up on the other side of the line close to the platform edge.
- The COSS is being asked to undertake other duties, leaving workers unsupervised on scaffolding towers.

As a result a range of recommendations and actions were agreed to address the concerns raised by the reporter. They included:

- all work shall be carried out as per the approved method statement by competent persons;
- a robust programme of monitoring by the contract manager is implemented;
- Southeastern will implement a schedule of monitoring of works; and
- all findings to be included for discussion in the joint monthly performance review meetings.

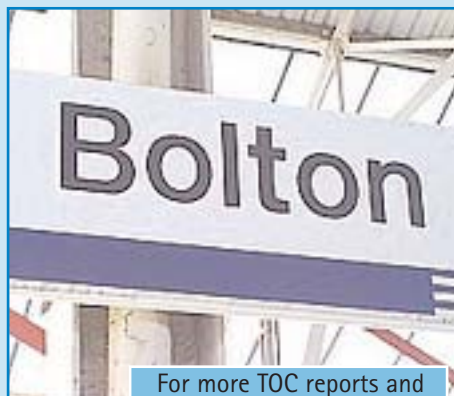
CIRAS was contacted by a reporter concerned by the general state of the car park at Bolton station. A pile of tyres appear to have been dumped and could attract more fly-tipping, potentially posing a fire hazard in close proximity to the running line. There is also loose wood lying around.

When the report was received, the tyres and wood which had been fly tipped in the car park had already been reported to our facilities maintenance contractor to arrange removal.

Unfortunately they did not originally give any priority to this. This has now been rectified and the offending items were cleared as a matter of priority.

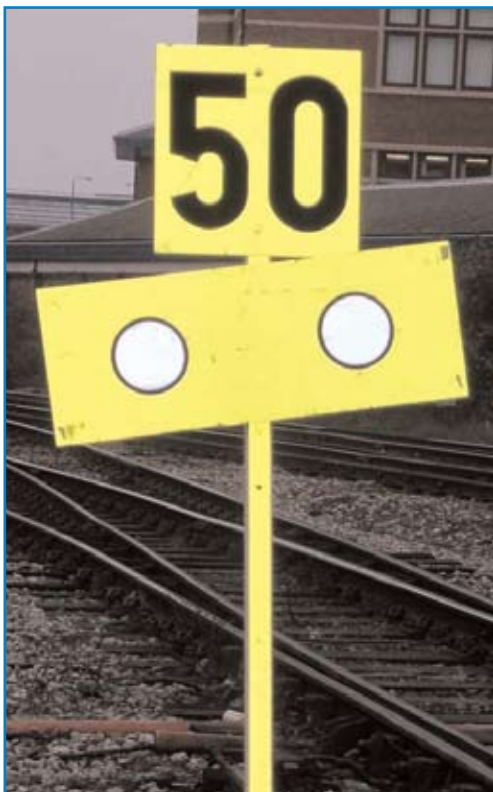
The first concern is that the TSR boards are always dirty and many are no longer reflective making them difficult, if not impossible, to see at night. This poses an obvious hazard that a driver could unknowingly travel through a speed restriction at an inappropriate speed. The reporter adds that simply cleaning the boards does not work as they are covered in a number of years' worth of dirt and oil. Could Network Rail consider replacing the TSR boards in this area and ensure they are clean and visible in all conditions?

*All the remaining boards have been cleaned and checked*

All the speed boards at the Ipswich depot have been checked and a number of boards were found to be damaged or dirty and these have been taken out of service. All the remaining boards have been cleaned and checked again so that they are fully reflective.

replaced by rail-foot-clamped speed board brackets. These come in two lengths, a short one for limited clearance use and a standard length version.

Staff have been briefed on when each type should be used. An information poster has also been placed within the board storage area as a permanent reminder to staff.

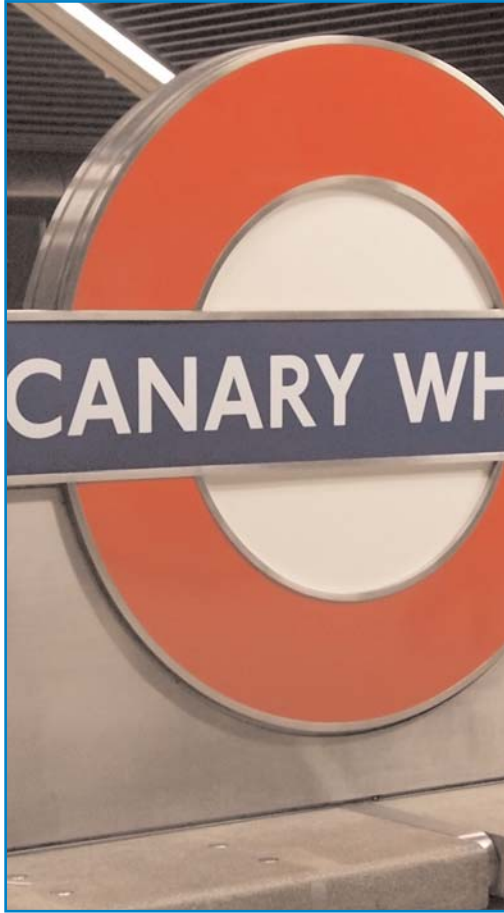
Canary Wharf underground station

A reporter is concerned about untrained staff handling safety critical calls at the control centre based at Canary Wharf.

members are working which, during meal breaks, is reduced to two people operating the phones. If staff are absent due to sickness or annual leave, staff from other teams in the centre are asked to cover the roles to ensure the calls are answered promptly. But these staff are not trained as control centre operators and only take messages for the operatives to call back, which the reporter fears could lead to a safety critical issue being misinterpreted or errors being made.

A recruitment campaign is underway with adverts for control centre staff at every level including a new control centre manager. Additional overtime has been authorised to keep levels above a minimum and no untrained staff are currently taking fault calls.

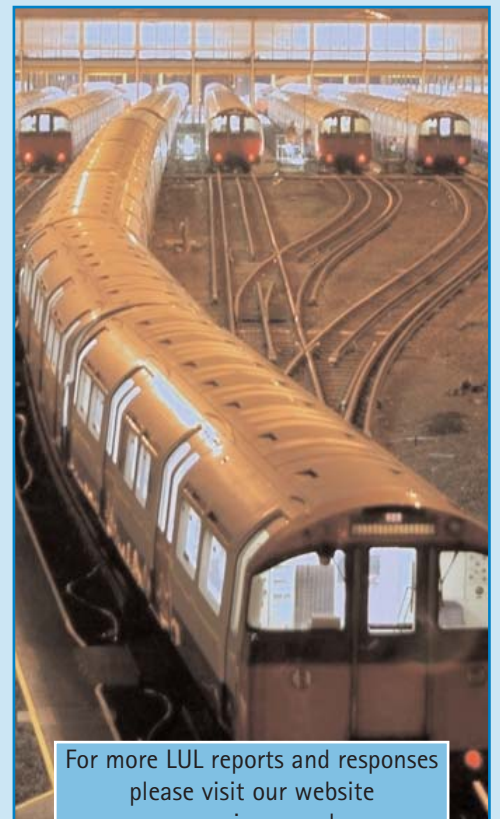
A reporter is concerned that, for some time, the traction earth detection equipment has been picking up traction earth defects when trains enter and exit on section 10 at Northfields and Ealing Common depots and section 44 at Cockfosters depot.

The correct procedure when a genuine earth defect is identified is for staff to cancel the alarm in the control room, refer to the traction earth detection diagrams and then contact Leicester Square substation control room. However, defects are being picked up as much as 15 times a day. This is leading to staff cancelling the alarm and referring to the diagram to check that a train is in the section because it is felt that the earth defect is not genuine.

The traction earth detection (TED) system located in the line controller's office will show very short duration earth faults when a train crosses over a section gap of less than 15m. For this reason the TED system has an alarm delay switch which should be switched on (this introduces a three second delay before alarming).

This switch should only be switched off when the line controller is locating a known fault. It was found that this switch was in the off position which resulted in lots of nuisance alarms. Having switched this on these nuisance alarms have stopped.
