# Working together

## Defective warning horns in snowy weather

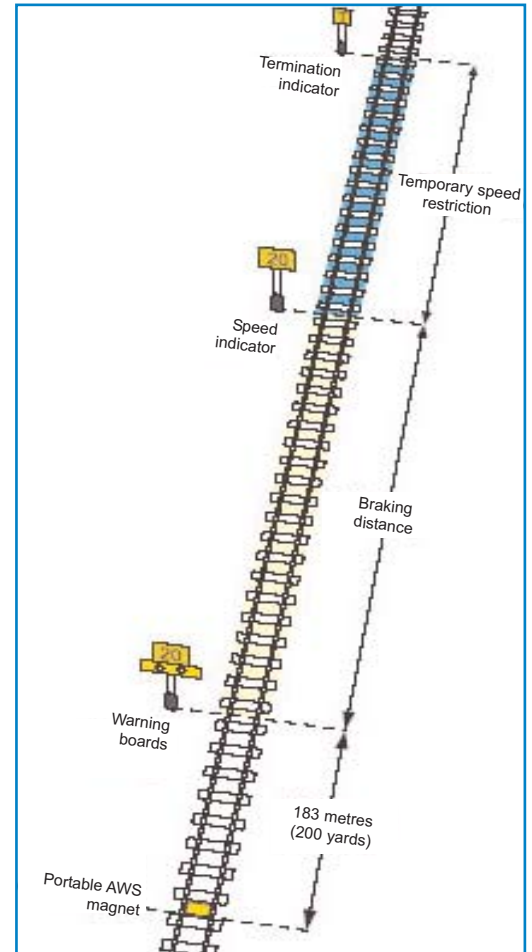
The first concern is that the TSR boards are always dirty and many are no longer reflective making them difficult, if not impossible, to see at night. This poses an obvious hazard that a driver could unknowingly travel through a speed restriction at an inappropriate speed. The reporter adds that simply cleaning the boards does not work as they are covered in a number of years' worth of dirt and oil. Could Network Rail consider replacing the TSR boards in this area and ensure they are clean and visible in all conditions?

This presents two problems: the first being that sometimes the OLE posts are on a curve and so the board is placed out of the driver's direct line of sight; and the second is that the boards are not secure when placed in the buckets and can easily fall over. In both instances the driver may not see the board and apply sharp, sudden braking when realising they are in a speed restriction. Could Network Rail re-brief staff on the correct positioning of these boards?

The third concern is about the use of limited clearance speed restriction boards in place of normal speed restriction boards. The reporter comments that it is common in the Ipswich and Felixstowe areas for limited clearance boards to be used as the standard when there is, in fact, no limited clearance. The reporter finds this confusing and does not understand the practice. Could Network Rail re-brief staff as to the correct use of different kinds of speed restriction boards?

*Temporary speed restriction basic arrangements*

All the speed boards at the Ipswich depot have been checked and a number of boards were found to be damaged or dirty and these have been taken out of service. All the remaining boards have been cleaned and checked again so that they are fully reflective.

The arrangements for board positioning have been reviewed and were found to be dictated by the equipment that was available in the stores.

replaced by rail-foot-clamped speed board brackets. These come in two lengths, a short one for limited clearance use and a standard length version.
